National Register of Historic Places Registration Form

historic name Viets Block (KHRI # 015-437; 015-438)

street & number 427, 429, & 431 State Street not for publication

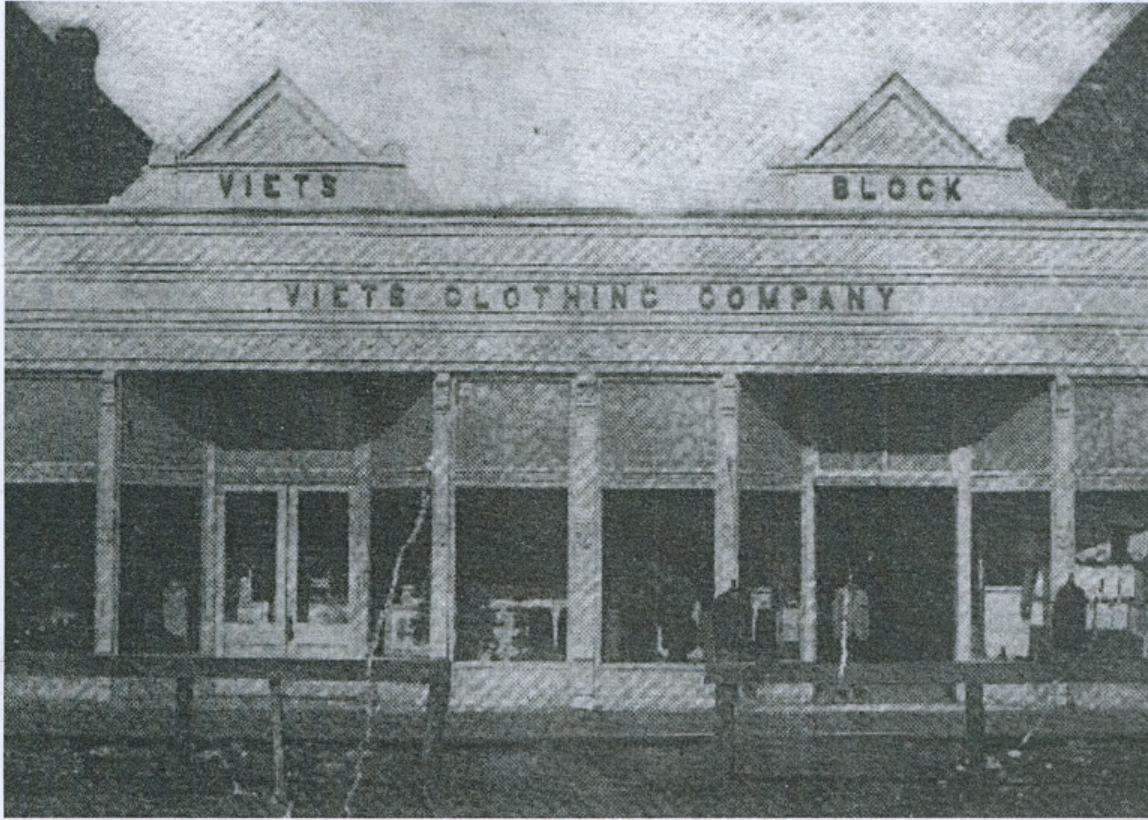
Figure 7: Early 20th century photograph of the Viets store, Augusta, KS

Charles Viets' building evolved over time to reflect its current appearance. The earliest known photograph of the building is an undated photograph from the early 1900s that depicts a one-story building with two storefront entrances housing the Viets Clothing Company. An advertisement in the *Augusta Gazette* in 1900 noted the building had been recently redecorated was a "Bower of Beauty."⁵
