National Register of Historic Places Registration Form

Historic name Reuter Organ Company Buildings
Other names/site number Wilder Brothers Shirt Factory; KHRI #045-3010-00106, 045-6867
Name of related Multiple Property Listing Historic Resources of Lawrence, Douglas County, Kansas

Street & number 612-616 New Hampshire Street
City or town Lawrence
State Kansas Code KS County Douglas Code 045 Zip code 66044

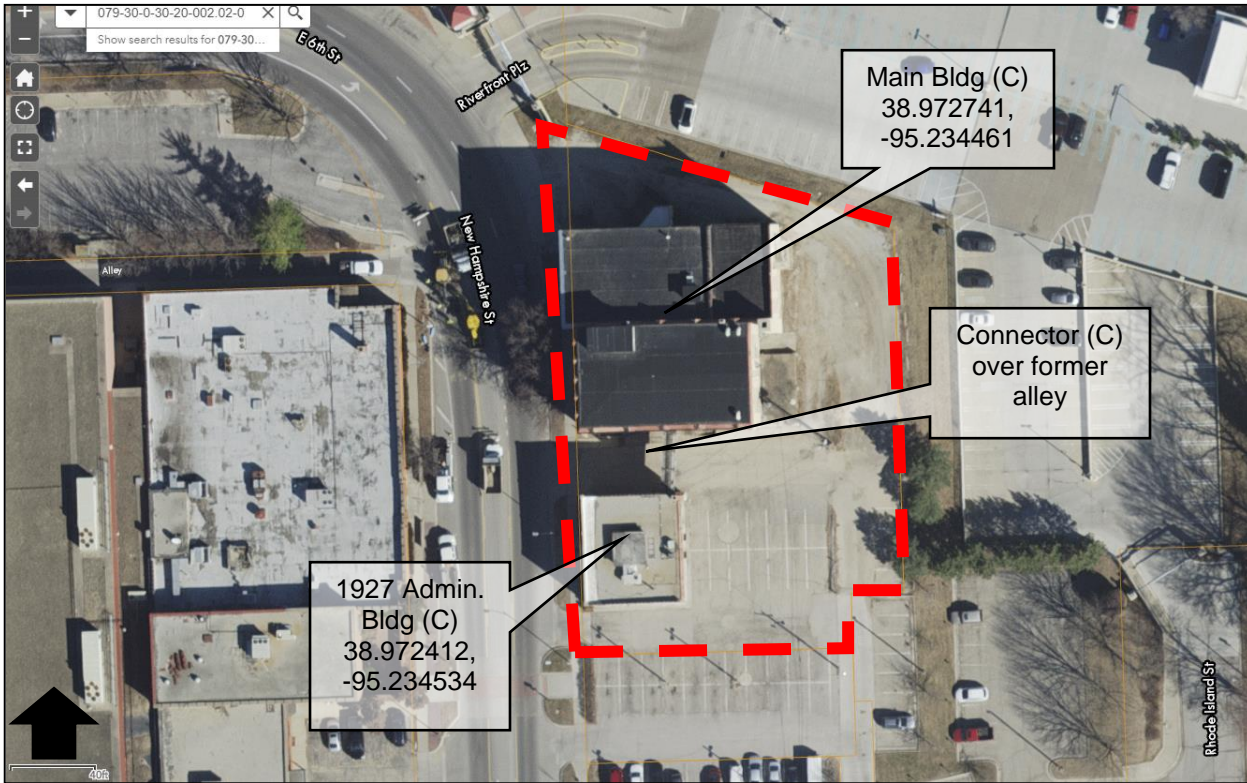
**Figure 2.** Site map of the nominated property. Dashed line represents the current parcel and nominated boundary. Source: Base map from the Douglas County, Kansas Assessor (gis.douglascountyks.org).

The Reuter Organ Company Buildings are located at 612 and 614-616 New Hampshire Street at the northeast corner of downtown Lawrence, Douglas County, Kansas (*Figures 1 & 2*). The nominated property at the southeast corner of 6<sup>th</sup> and New Hampshire streets includes two contributing buildings and one contributing structure, the covered walkway between the two buildings.<sup>1</sup> The main building on this parcel is the stone three-and-a-half story Wilder Brothers Shirt Factory, constructed in 1882, and remodeled in 1919 for the Reuter Organ Company. To the south of this across a former alley is the two-story brick Reuter administration building constructed in 1927. A metal walkway over the alley connects the two buildings at the second stories (*Photo 1*). The remainder of the parcel is hardscape. The buildings retain a high level of integrity from its period of significance associated with the Reuter Organ Company.

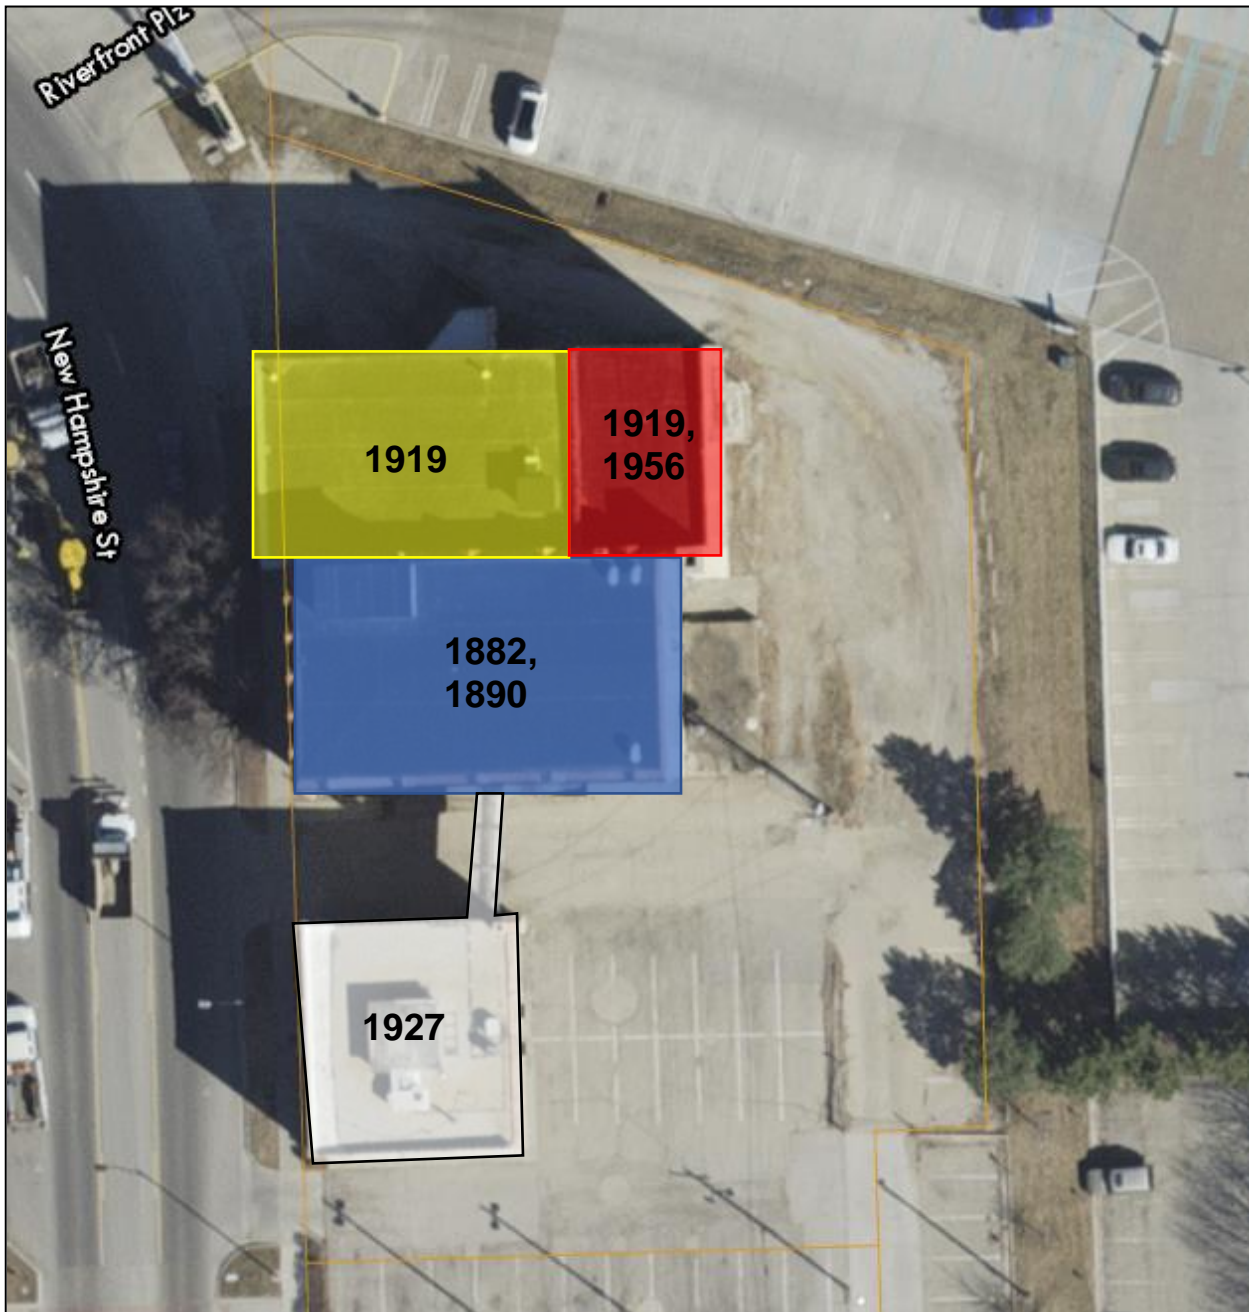
**Figure 4.** Diagrammatic plan, showing dates of construction.

The main Reuter Organ Company Building occupies the north end of the property. The south mass was built in 1882 for the Wilder Brother Shirt Factory. Today the three-and-a-half story stone building with offset T-shaped plan features additions and alterations mostly undertaken by the Reuter Organ Company during their acquisition and utilization of the building. The oldest block of the stone building is a rectangular portion slightly setback from the sidewalk. The upper mansard half-story was added in 1890. That year, a small one-story rectangular mass was added to the northwest corner of the building and a two-story engine room added to the northeast corner. When the Reuter Organ Company acquired the property in 1919, they removed these additions and built a new wing. The company also increased the size of the window openings within the 1882 portion. In 1956, a concrete block addition was built atop and around the one-story stone kiln at the northeast corner of the building (*Figures 4 & 5*). The roof level contains a penthouse.

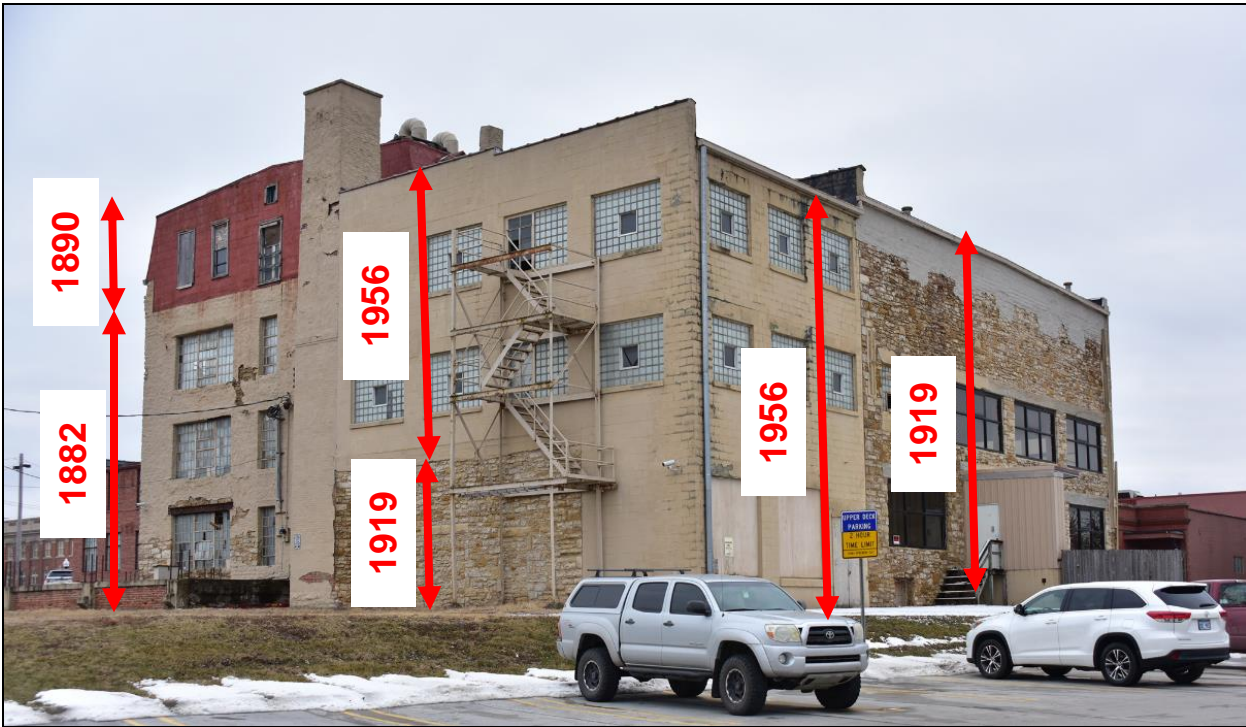
Figure 5. East and north elevations, looking SW with dates of construction added.

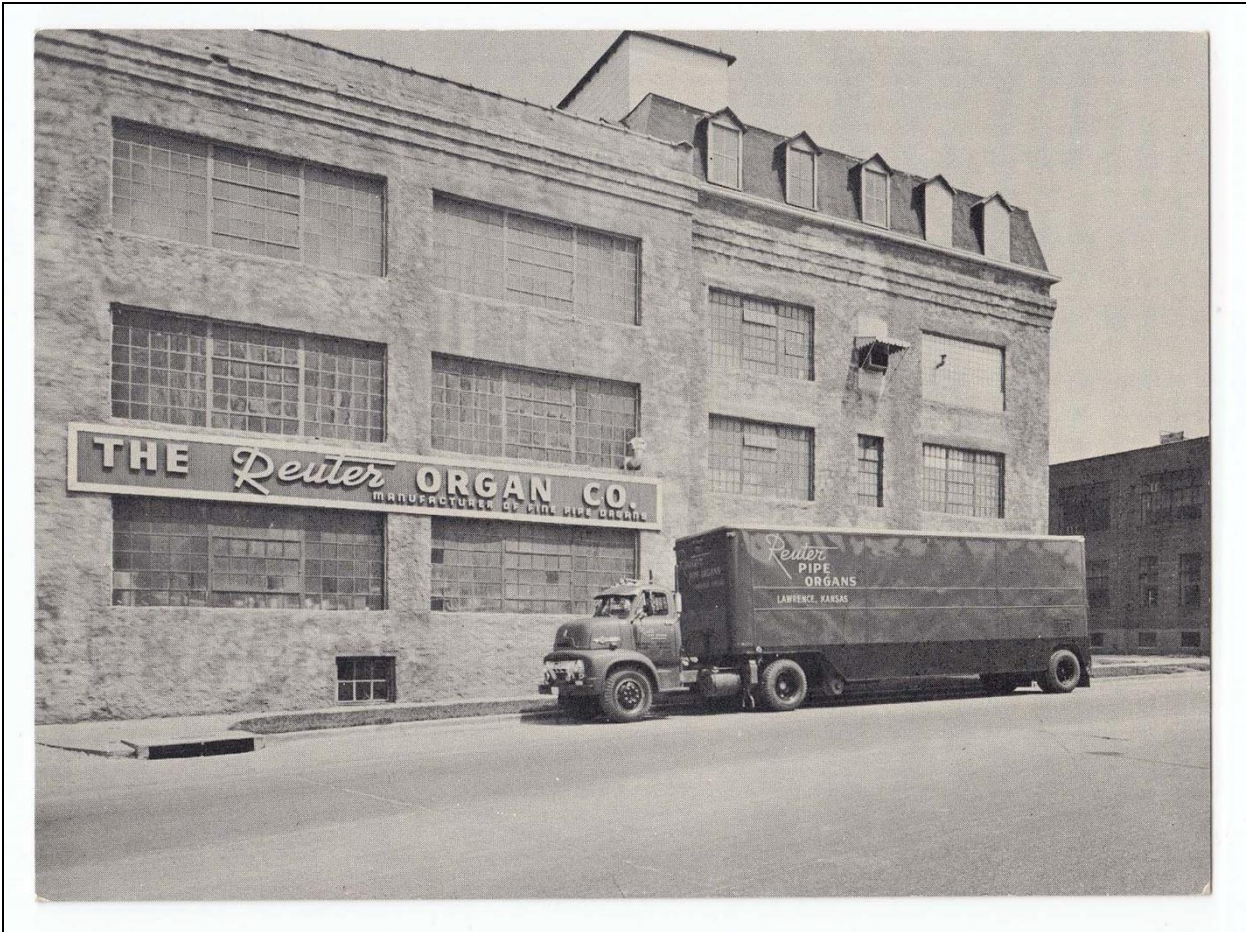
**Figure 6.** Circa 1956, showing glass block window unit.

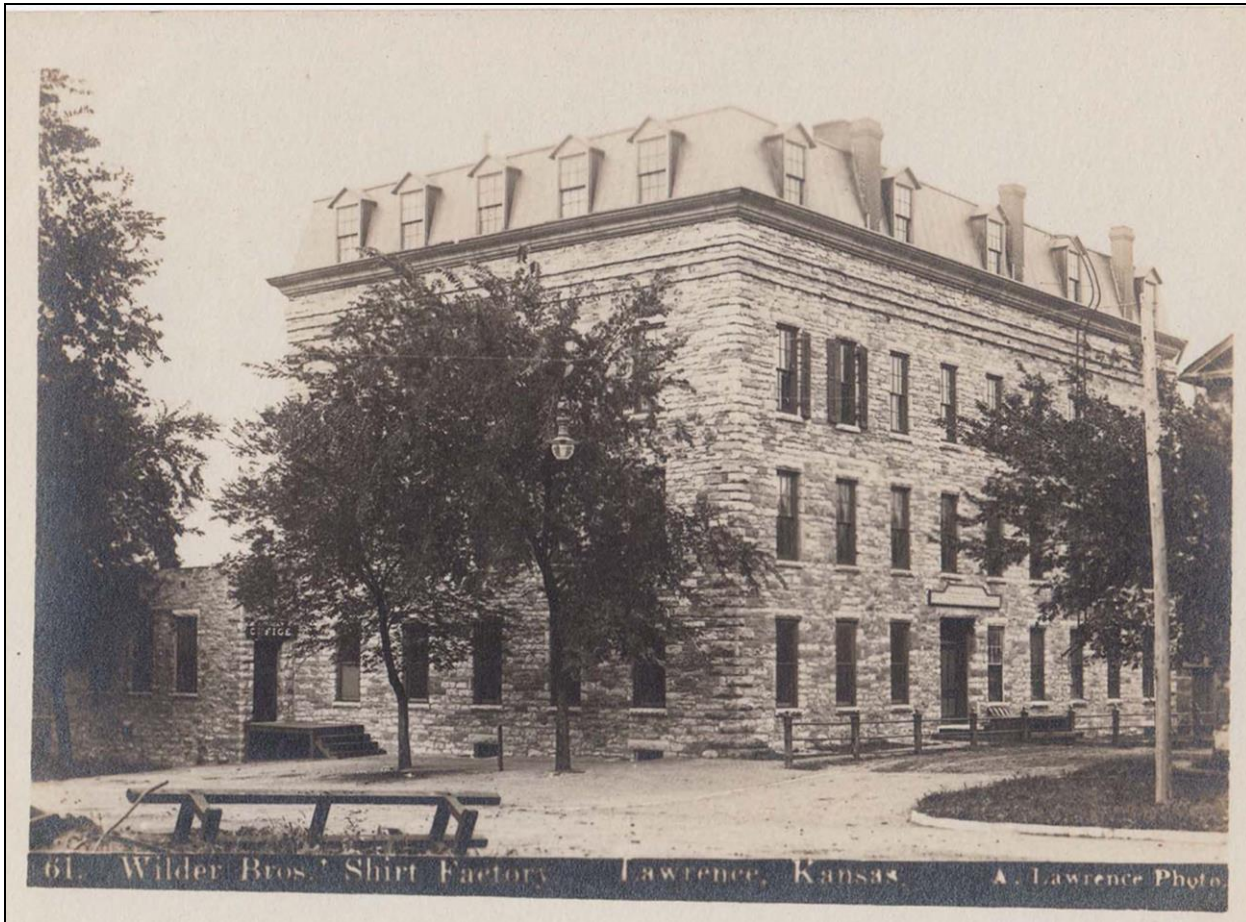
**Figure 7.** Undated (post-1890) image showing window configuration prior to Reuter company occupation.

<sup>3</sup> This opening is from the initial 1882 construction. When built, the west façade had five evenly spaced bays of this size at each story (*Figure 7*). The north two and south two bays were combined to form the masonry openings seen today.

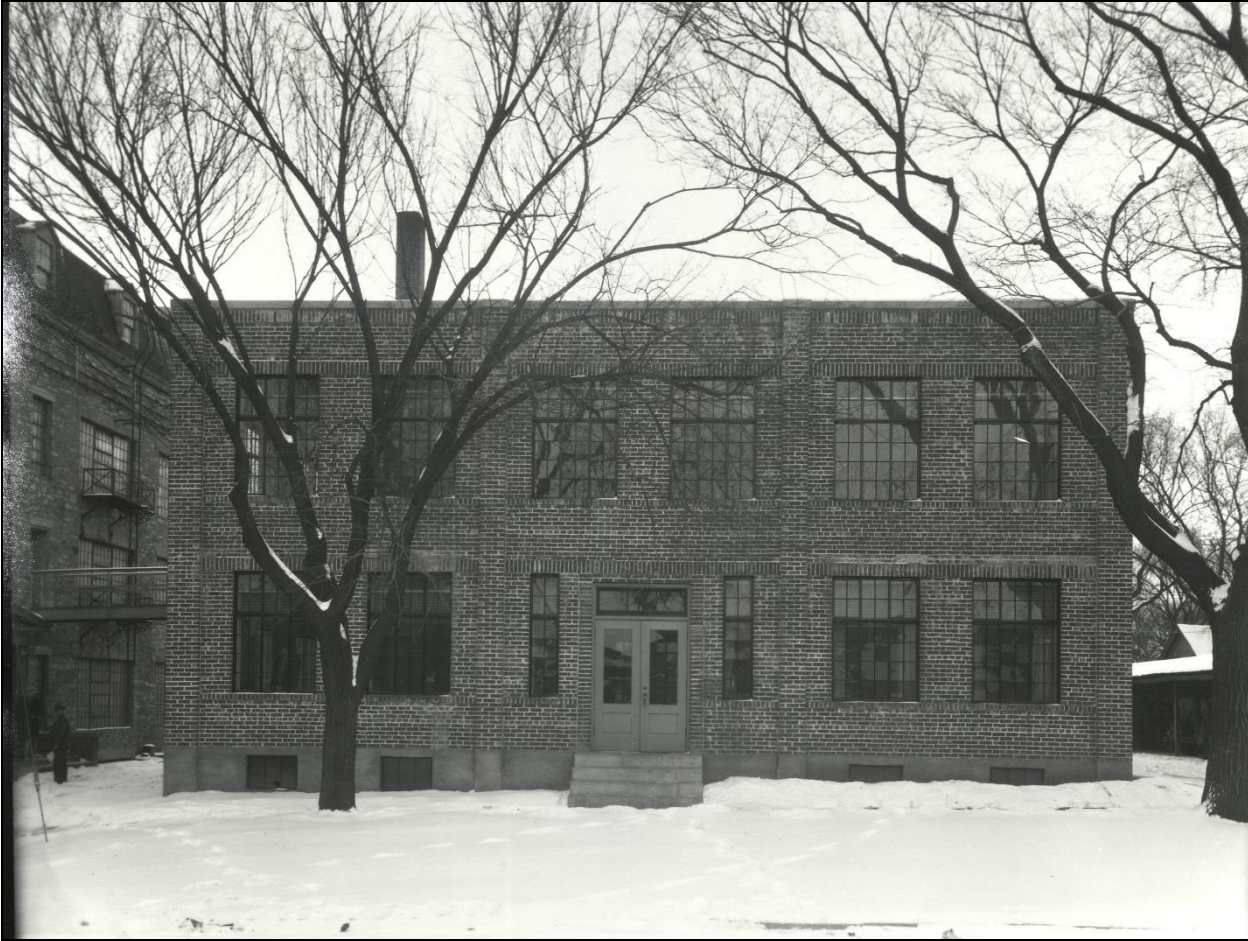
**Figure 8.** Circa 1927 photo of the Admin building with walkway shown.

The 1882 and 1927 buildings have been connected by an elevated walkway since 1927 (*Figure 8*). When constructed, the walk was open with metal railings and steel I-beam supporting the walkway. Today, the connector is enclosed and has a flat roof; the walls are standing seam metal and three windows pierce the east and west sides. The interior of the connector has wooden plank flooring and metal walls and ceiling. Although altered, the connector is considered contributing due to its historic presence; the structure of the walkway remains although enclosed.<sup>4</sup>
