National Register of Historic Places Registration Form

Historic name Washington Grade School

Street & number <u>305 Main Street</u>	N/A	not for publication
City or town <u>Hays</u>	N/A	vicinity
State <u>Kansas</u> Code <u>KS</u> County <u>Ellis</u>	Code <u>051</u>	Zip code <u>67601</u>

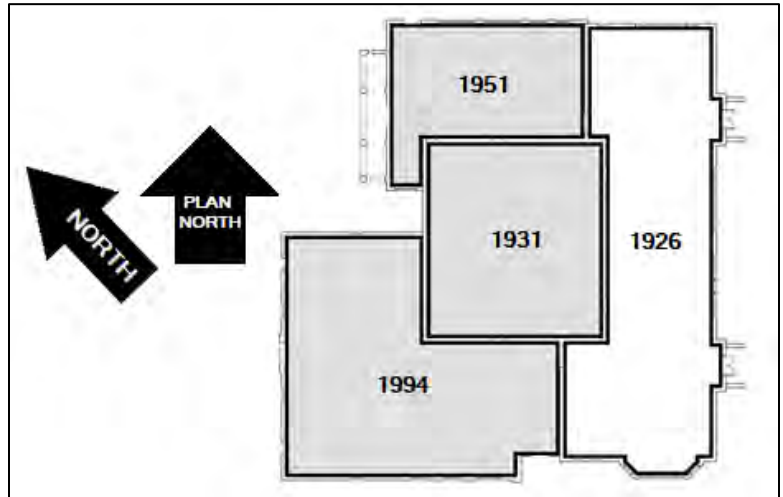
Figure 01: Washington School layout with modified orientation.

While the parcel is primarily characterized by grassy expanses and mature trees, concrete and asphalt pavement extends from the playground area to the northwestern side of the school. For clarity, the following description orients the building to the east. Therefore, the primary (southeast) elevation is the east elevation; the southwest elevation is the south elevation; the northwest elevation is the west elevation, and the northeast elevation is the north elevation (**Figure 01**).

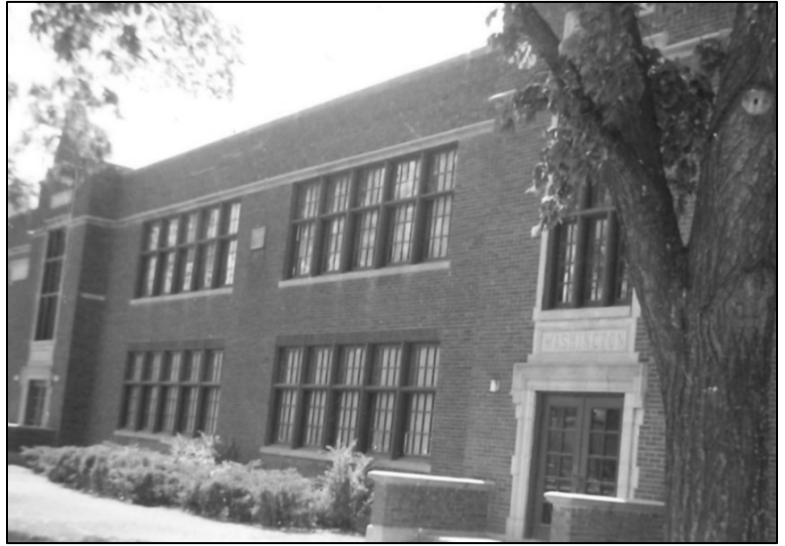
Figure 02: 1970 Survey photograph showing historic muntin configuration.

The central two bays contain a ganged set of five one-over-one windows at each story. (**Photos 02, 04**). Historically, each of these units contained multi-paned eight-over-twelve windows (**Figure 02**).

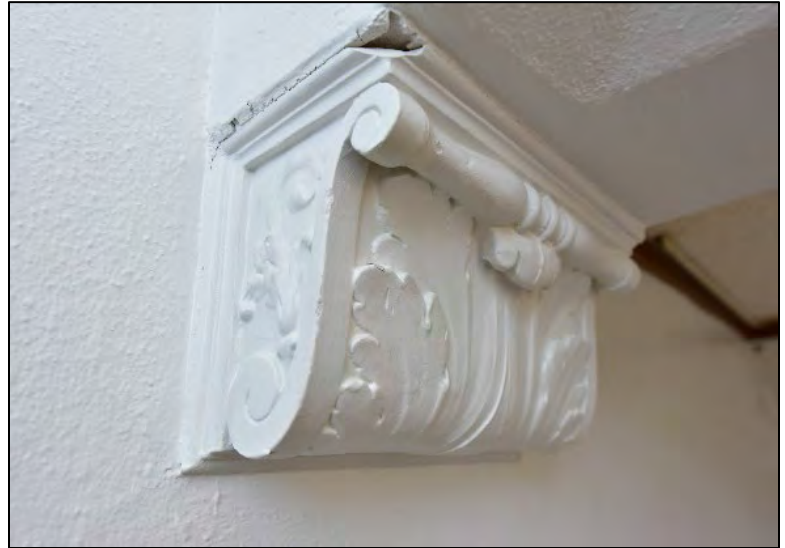
Figure 03: Typical plaster scroll bracket. Photo: Brad Finch, 2020.

Finishes in the recreation space include plaster walls, wood trim detailing, and acoustic tiles applied to the ceiling. Non-historic safety mats line the perimeter walls, and carpet covers the historic wood floor. A centrally placed skylight is likely an historic opening.¹² The stage space appears to maintain its historic wood flooring, plaster walls, and plaster ceilings. From the stage, the proscenium opening is also discernable and reveals plaster scroll brackets situated at both corners of the opening. From the stage, the proscenium opening is also discernable and reveals plaster scroll brackets situated at both corners of the opening.

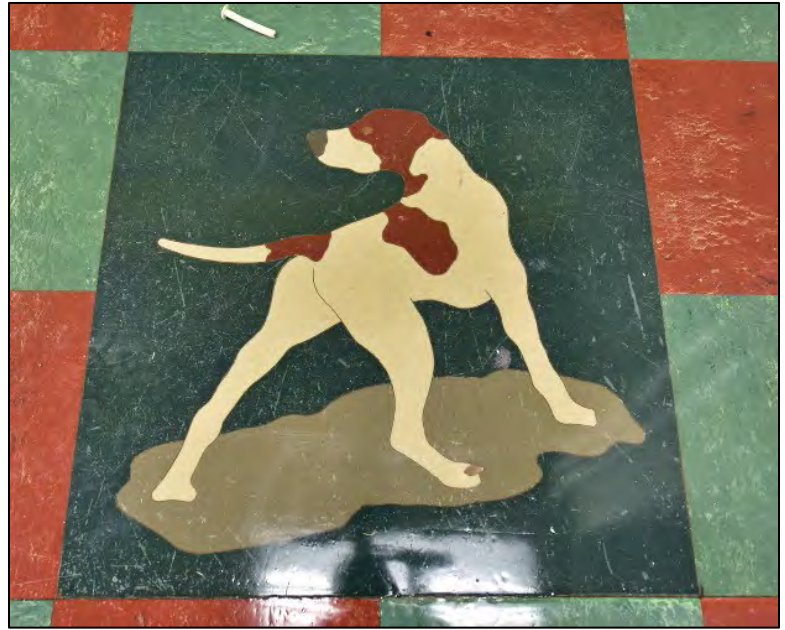
Figure 04: Typical thematic floor tile. Photo: Brad Finch, 2020.

tiles are arranged in a checkered pattern. A unique touch on the flooring are four thematic insets placed near the corners of the room; they depict a duck, a swordfish, a hound dog, and a sailboat (**Figure 04**). Due to newer suspension tiling and lighting, the ceiling is slightly lower than its historic height.

The remaining classrooms on the first floor share common traits. They are characterized by rectangular layouts with single entry points and recessed cloak rooms. The finishes in these spaces include checkered linoleum floor tiles, plaster walls, and acoustic tiles adhered to the ceiling. Like the south classroom, these rooms also contain thematic tile insets near their respective entries.

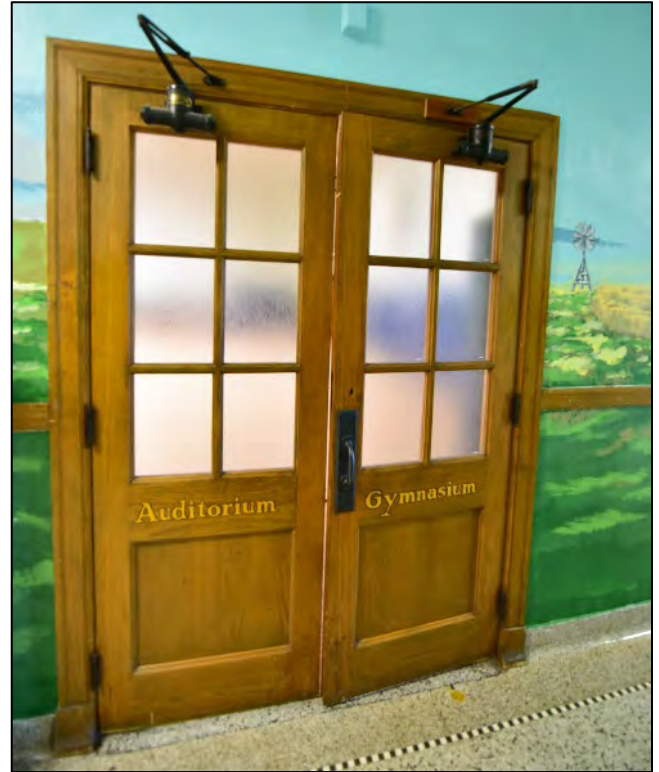
Figure 05: A gymnasium entry on the 1926 corridor. Photo: Brad Finch, 2020.

The gymnasium contains a two-story interior volume. A rectangular space appended to the western side of the 1926 building, the gymnasium encompasses a recreational area and a main stage on the western side of the gym flanked by two side-stage rooms. Four entry points provide access to the recreational area; two double-door entries located along the eastern wall lead to the main corridor in the 1926 school, a single door on the northern wall leads to the main corridor in the 1951 addition, and a single door on the southern wall leads to the hallway of the 1994 addition. The two double-doors are made of wood; the upper half of each door contains six frosted lites and the lower portion is indented with a single panel. Each set of doors retains its historic hardware, speed reducers, and hand-painted lettering displaying the words “Auditorium” and “Gymnasium” (**Figure 05**). Two entries situated at the opposite ends of the gymnasium’s western wall provide access to the side-stage rooms.

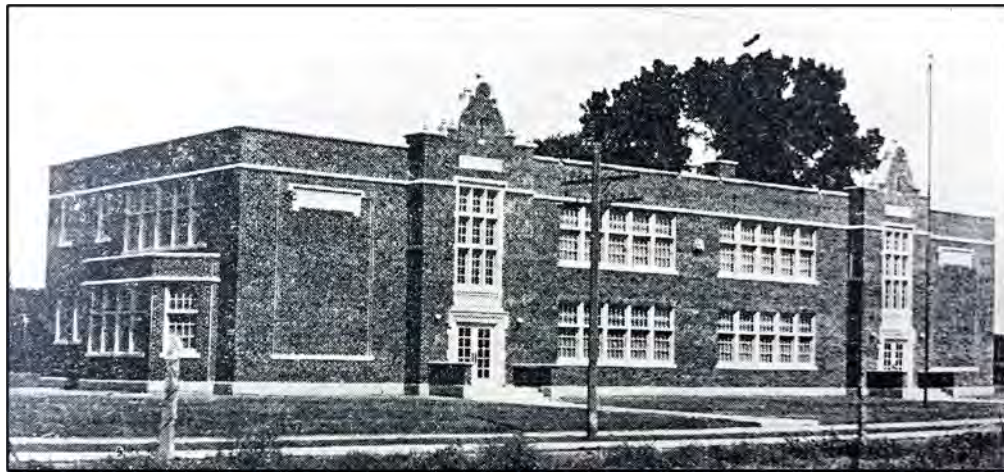
Figure 06: Southeast elevation of Washington Grade School, c. 1920s.

The Washington School (**Figure 06**) building itself followed Progressive Era design precedents. During the late nineteenth century, graded school facilities developed, and four-, six-, and eight-room buildings appeared in communities to

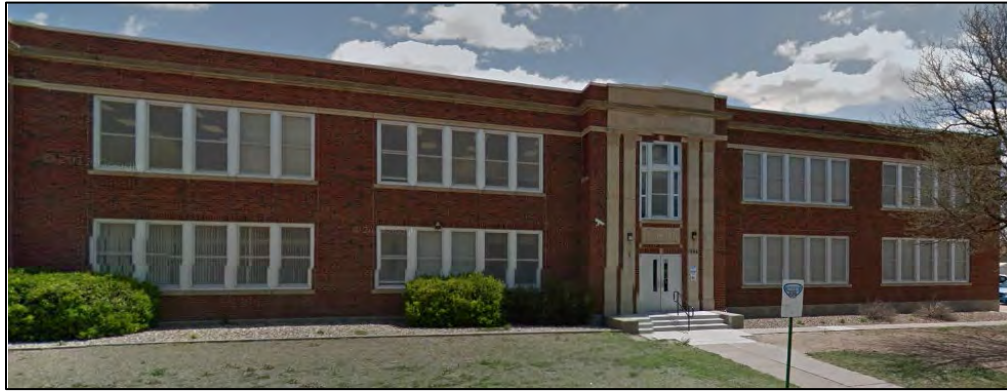
Figure 8: 1925 portion of Lincoln Grade School. Source: Google Streetview.

Built in the Commercial Style, Lincoln School's ornamentation is limited to stone pilasters surrounding the central entry, stone belt courses, and coping along the parapet.⁵⁵

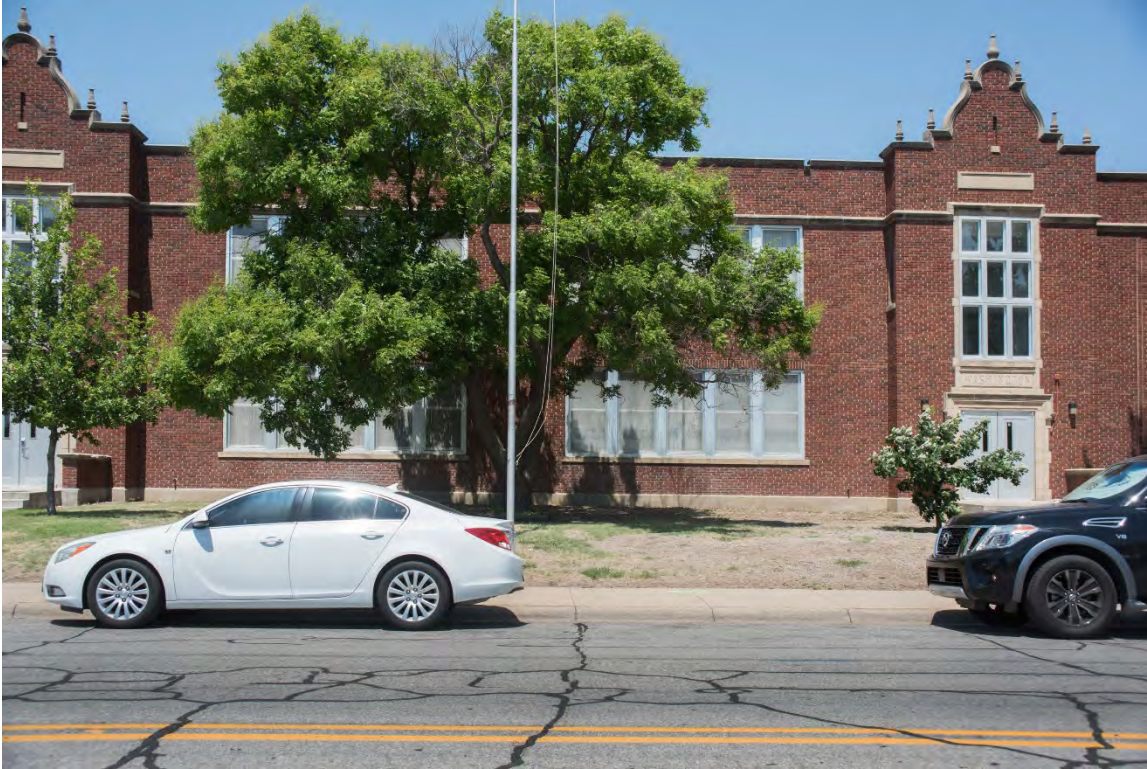
Photo 1: Front (east) elevation, northern entry, facing west

The second and fourth bays consist of shallow rectangular projections, each containing a double-door entryway (**Photos 01, 03**). A non-historic concrete stoop with three ascending stairs allows access to the two front entries. Historic knee walls, constructed from brick and topped with a stone coping, flank the stoop. A modern concrete ramp extends from the side of each stairway. Tabbed masonry surrounds and label mold lintels frame both entries. The doors themselves are non-historic replacement units. An etched stone entablature above each entrance reads "WASHINGTON". The top of each entablature abuts a stone sill, above which is a multi-panel window unit. Each nine-pane unit, defined by two vertical mullions and two horizontal mullions, extends vertically and intersects a stone belt course, creating a hood above the windows. Historically, each of these units contained a network of muntins between each of the mullions (**Figure 02**). Above the multi-paned windows, a shaped Flemish parapet caps the entry bays. Raked stone coping outlines each parapet, and seven stone finials accent the coping. The faces of both parapets contain a centrally placed slit window indentation. Historically, the sides of each entry bay projection contained rectangular vents. Although these vents have been removed, the masonry openings remain, and wood framing is still visible on the northeast projection.

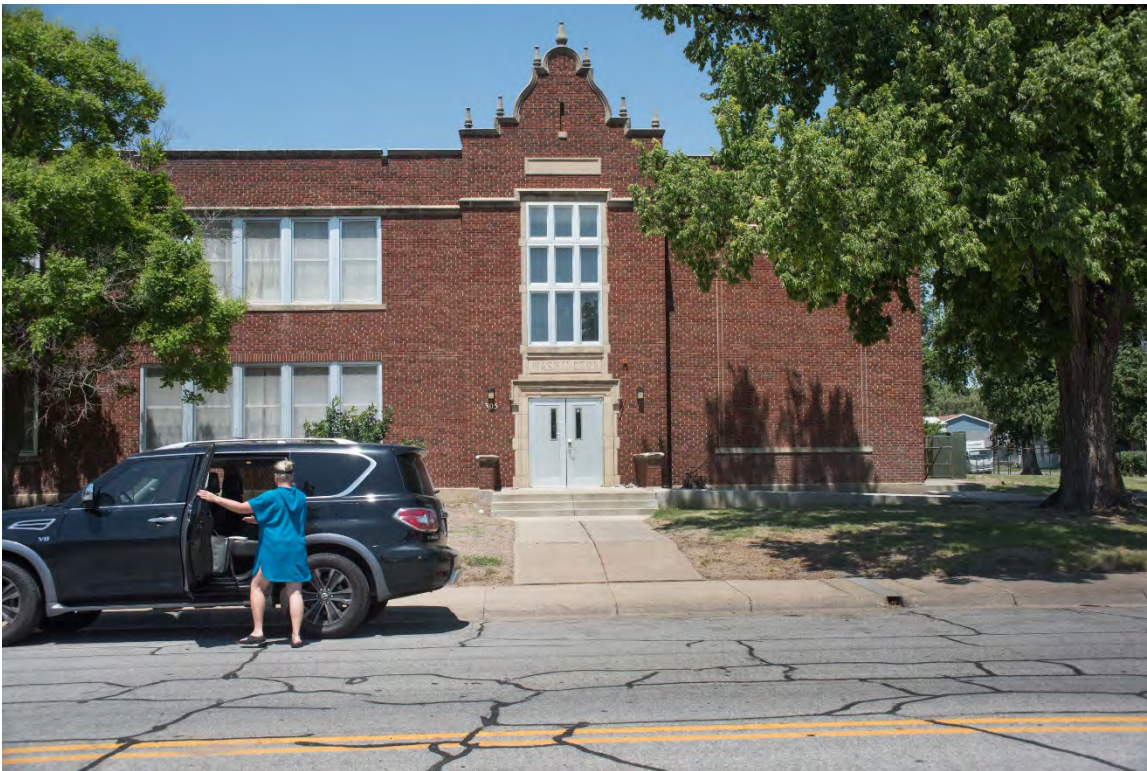
Photo 2: Front (east) elevation, central bays, facing west

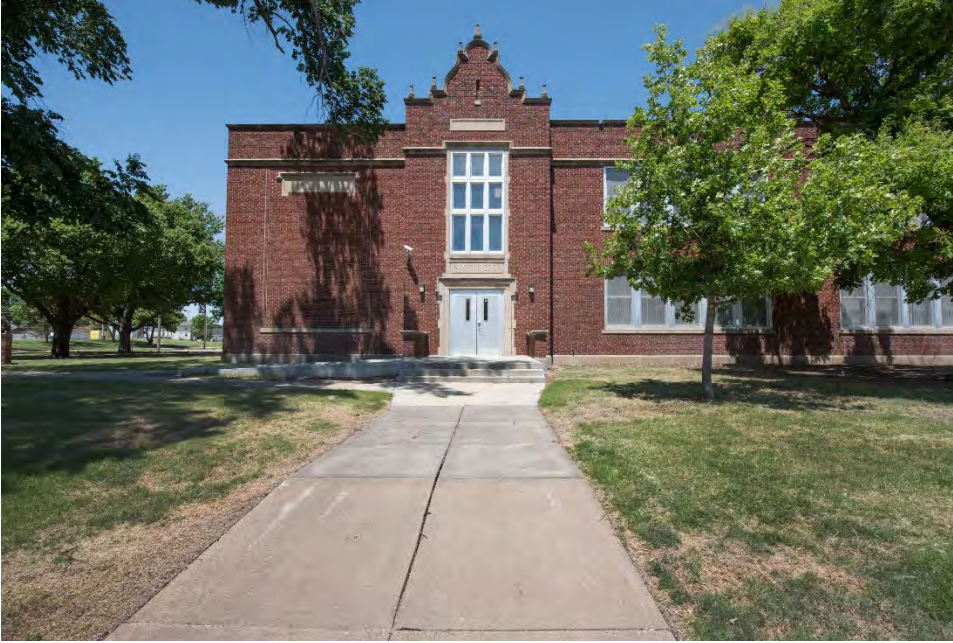
Photo 3: Front (east) elevation, southern entry, facing west

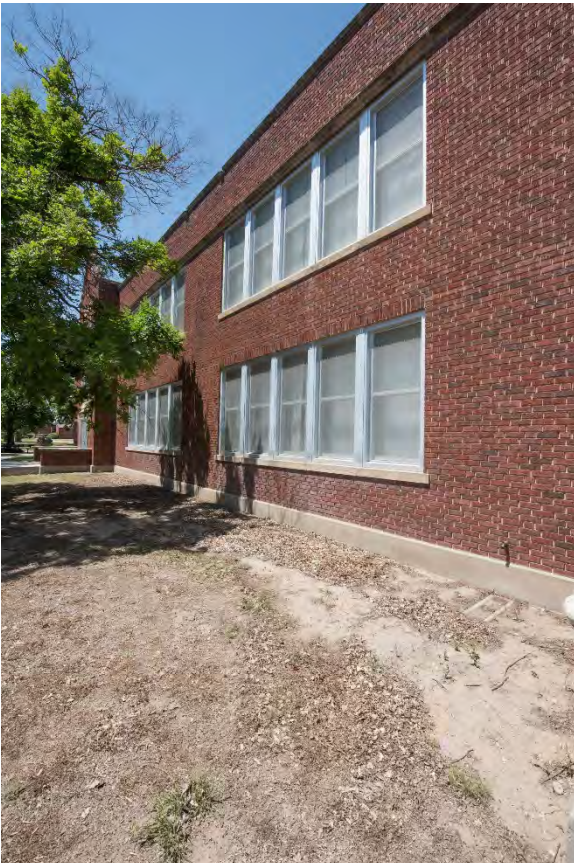
Photo 4: Front (east) elevation, facing southwest

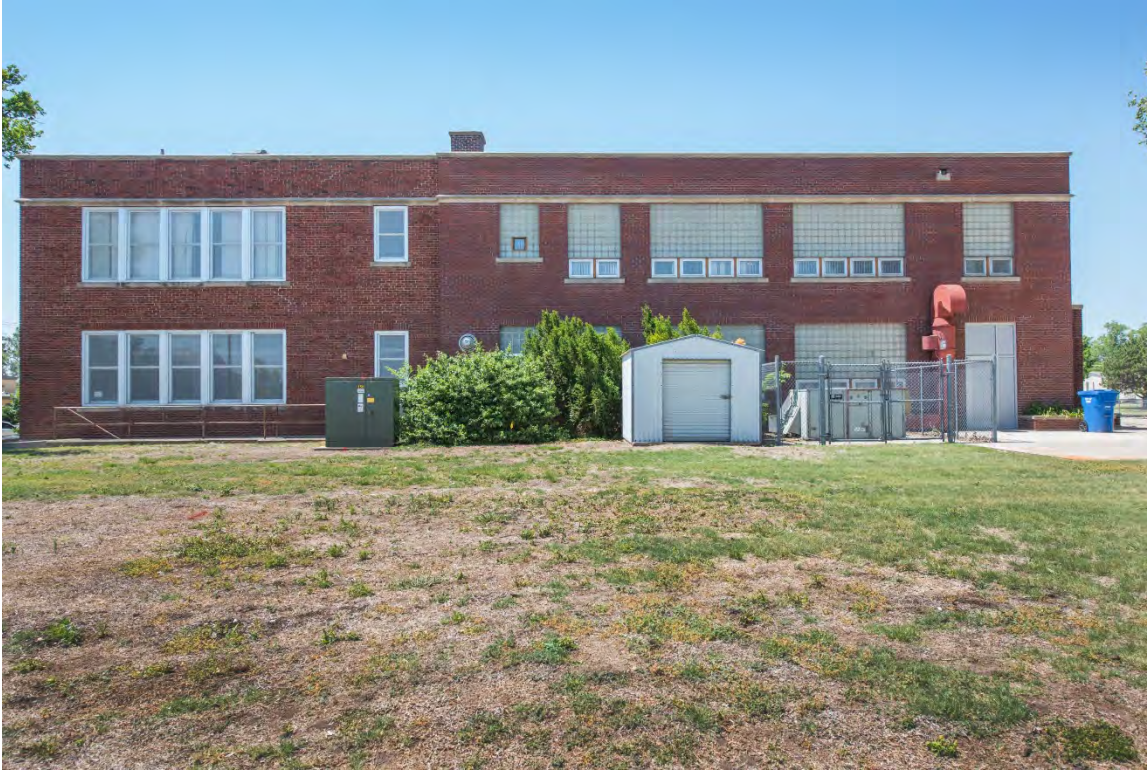
Photo 5: North elevation, facing south

Two uneven bays organize the two-story north elevation of the 1926 building. The primary bay of this elevation contains a ganged set of five one-over-one windows at each story (**Photo 05**). The dimensions and treatment of the masonry openings match those on the east elevation. To the north of the ganged windows, a single one-over-one window pierces the wall at each story. Directly in front of the north elevation, a flight of concrete stairs descends along the building, allowing exterior access to the basement. A metal handrail is located along the stairwell. A modern covered utility box is situated to the north of the stairwell. The 1951 addition extends to the west of the 1926 building.

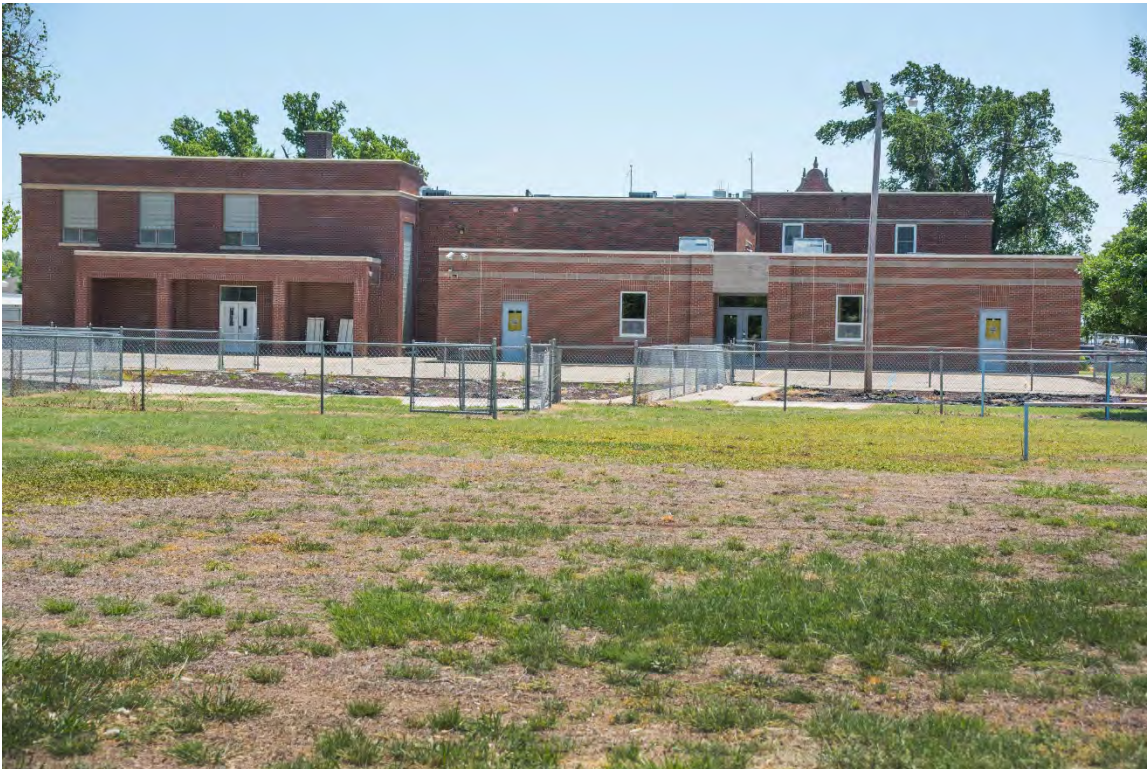
Photo 6: West elevation, facing east

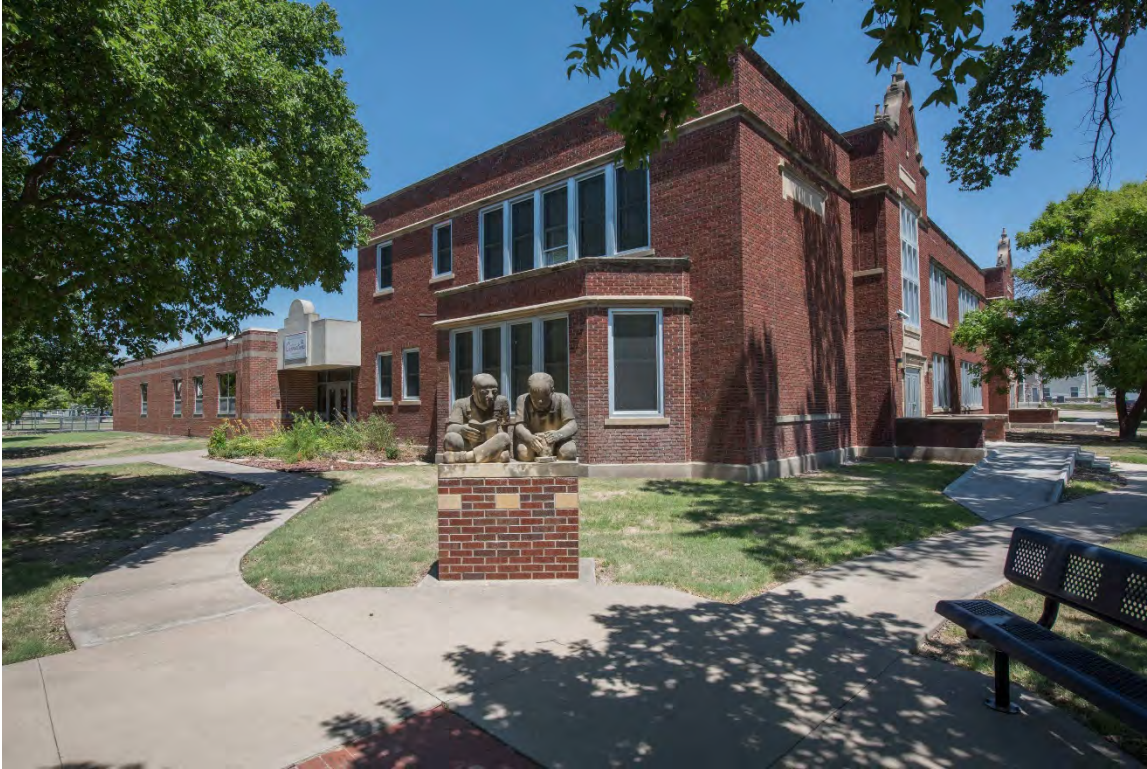
Photo 7: South elevation, facing northwest

The south elevation of the 1926 portion contains asymmetrically placed openings (**Photos 07, 08**). On the first story, two small rectangular windows are paired in close proximity to each other on the elevation's western half. On the eastern half

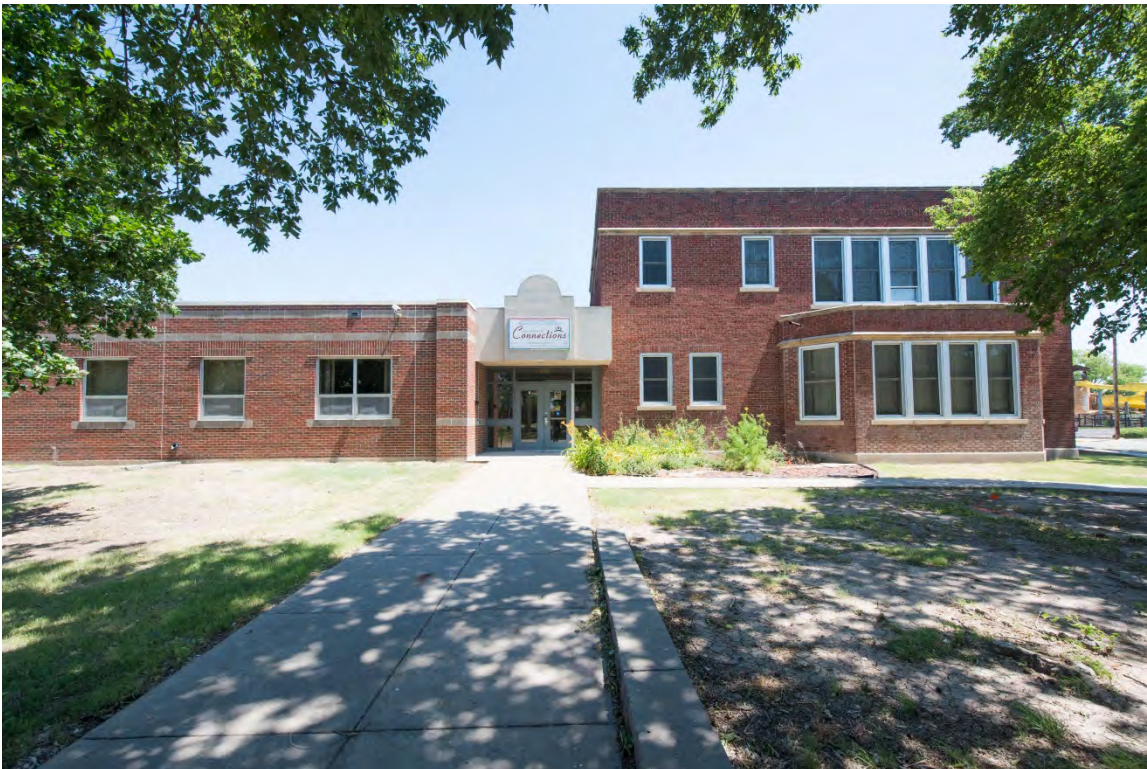
Photo 8: South elevation, facing north

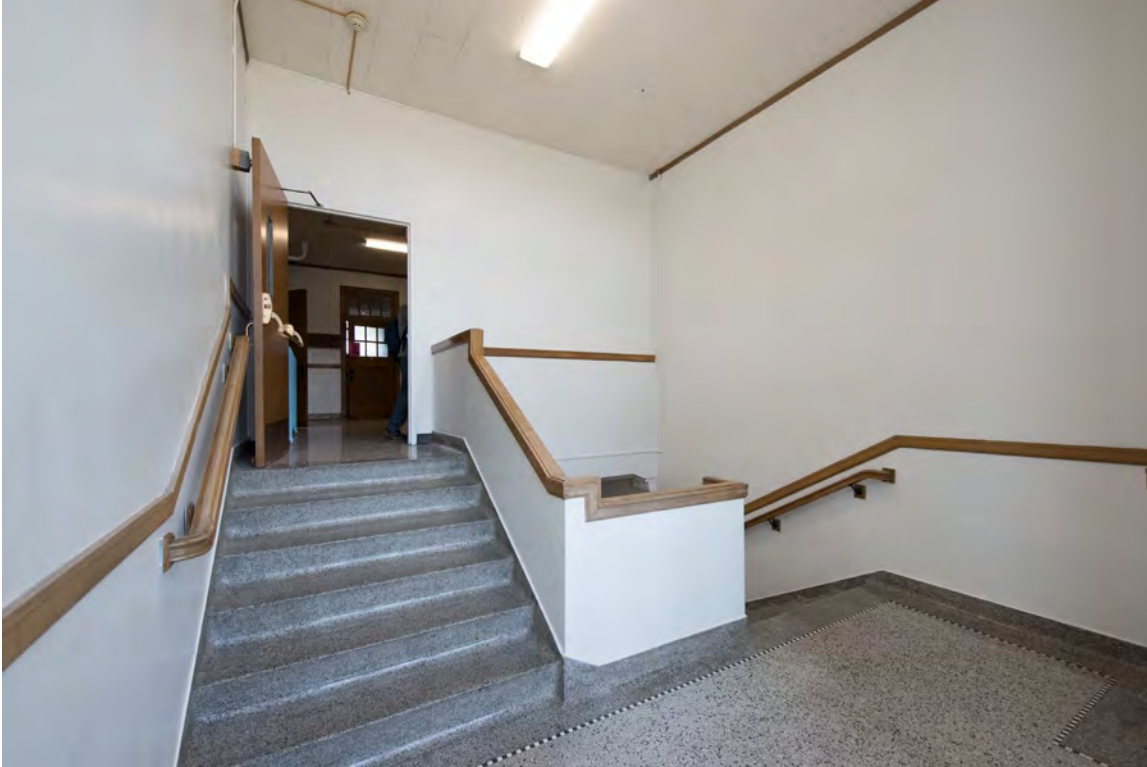
Photo 9: 1926 Building, south stair, landing between first and second floors, facing northwest

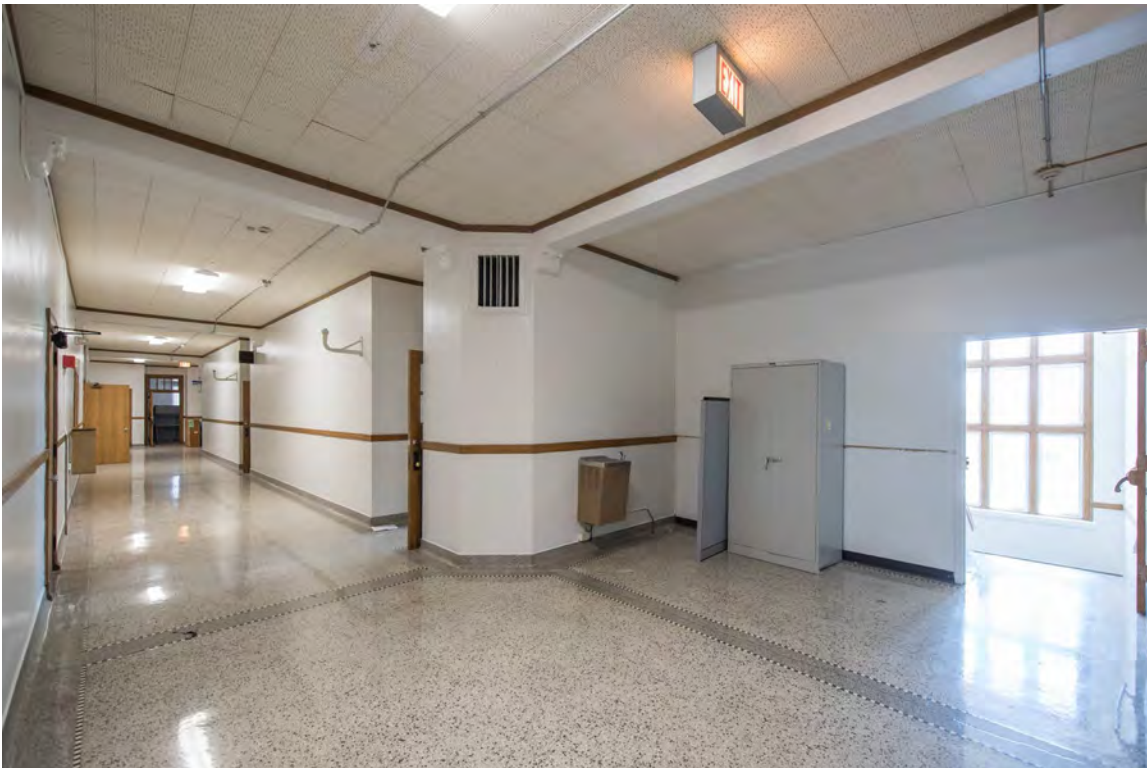
Photo 10: Second floor corridor (1926 building), facing northeast

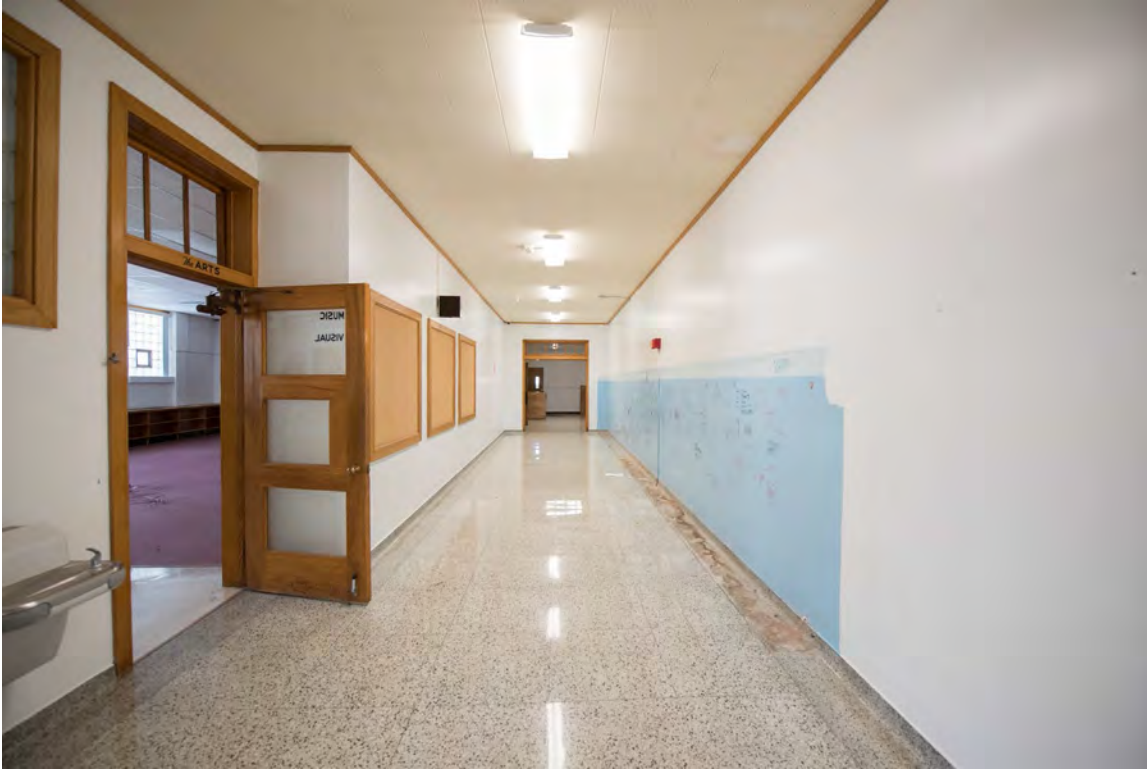
Photo 11: Second floor corridor (1951 addition), facing east

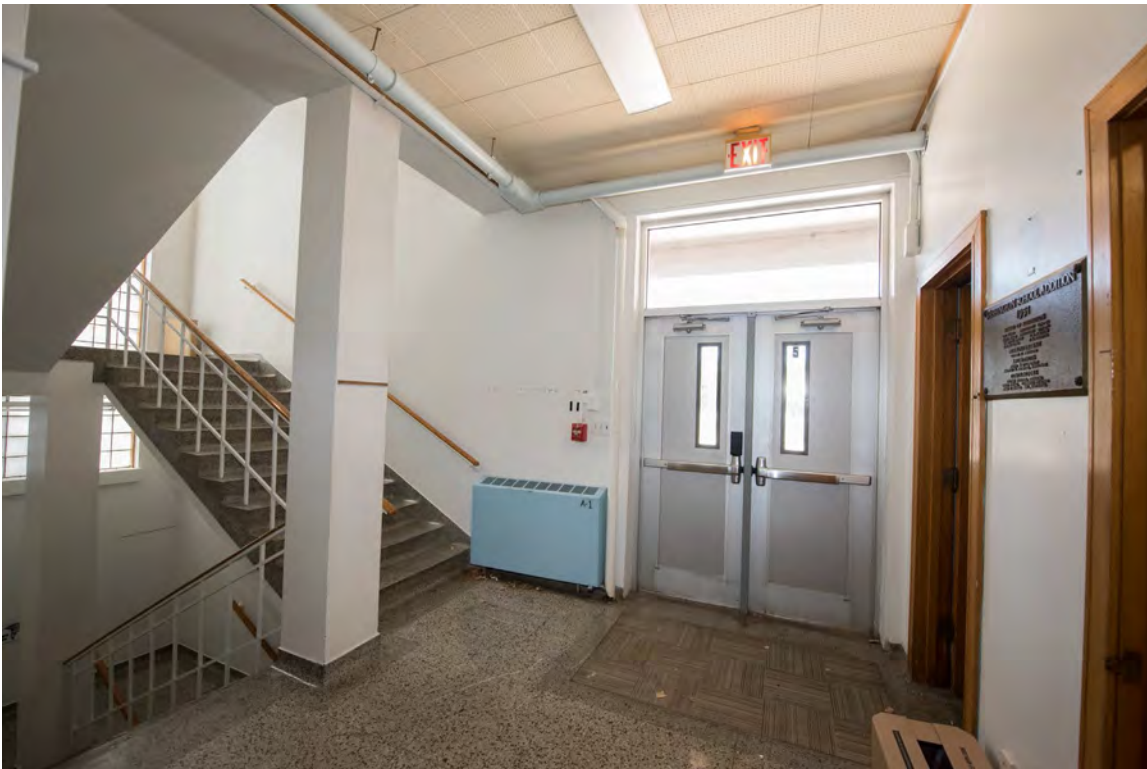
Photo 12: First floor vestibule (1951 addition), facing west

The square entry vestibule, centrally located on the western end of the 1951 addition, provides an exterior entry point at the rear of the school (**Photo 12**). The entry corridor opens to a switchback stairwell, which provides access to a partial basement and to the second floor of the 1951 addition. A two-story glass block window pierces the southern wall of the stairwell. The opposite side of the vestibule provides access to a utility room and a small service area. The entry vestibule leads to the addition's main corridor, which provides access to the first-floor classroom and a storage room.

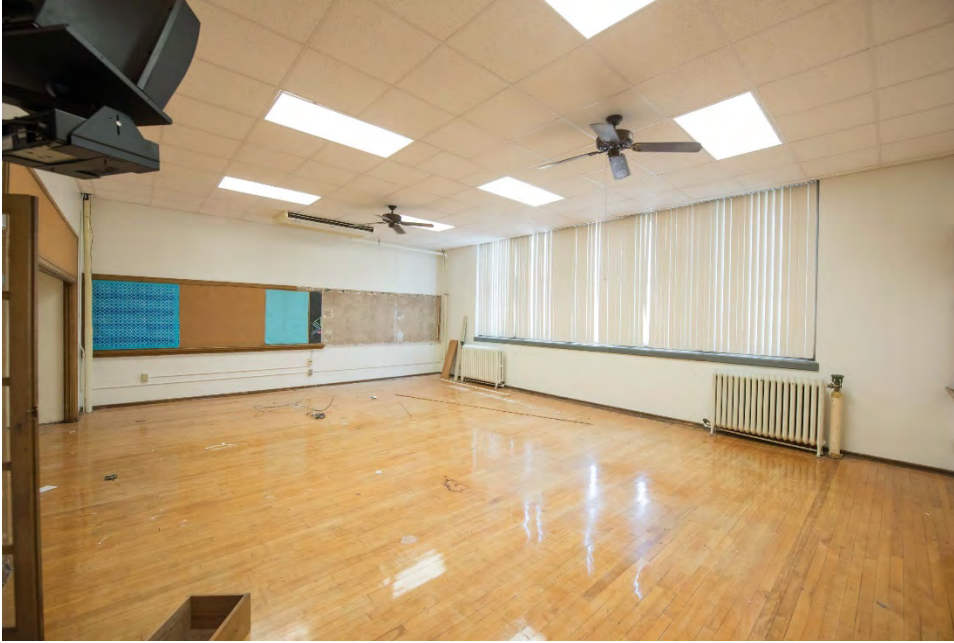
Photo 13: Typical classroom (1926 building), second floor, facing northeast

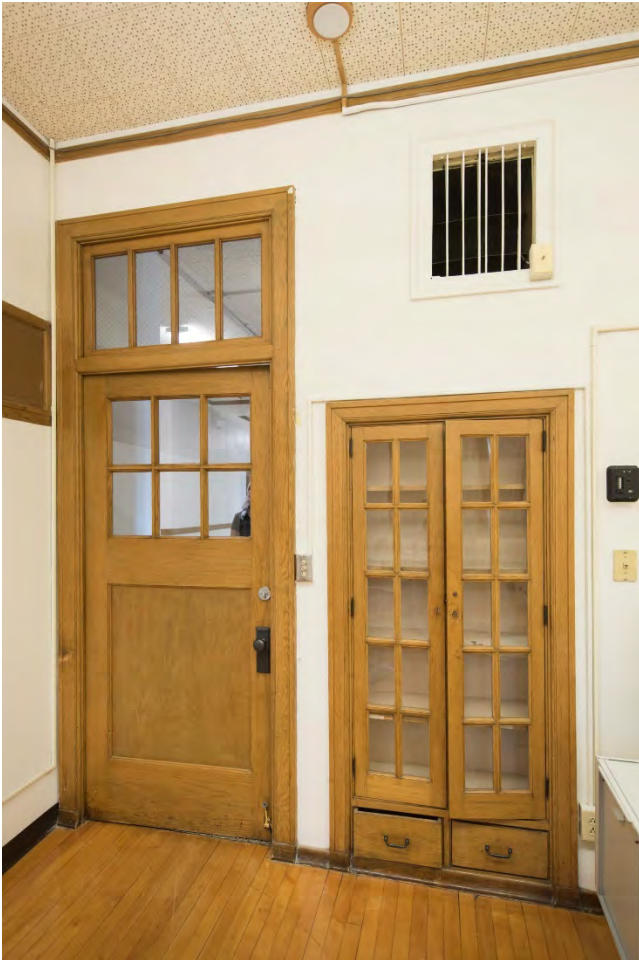
Photo 14: Typical built-in cabinet (1926 building) second floor, facing north

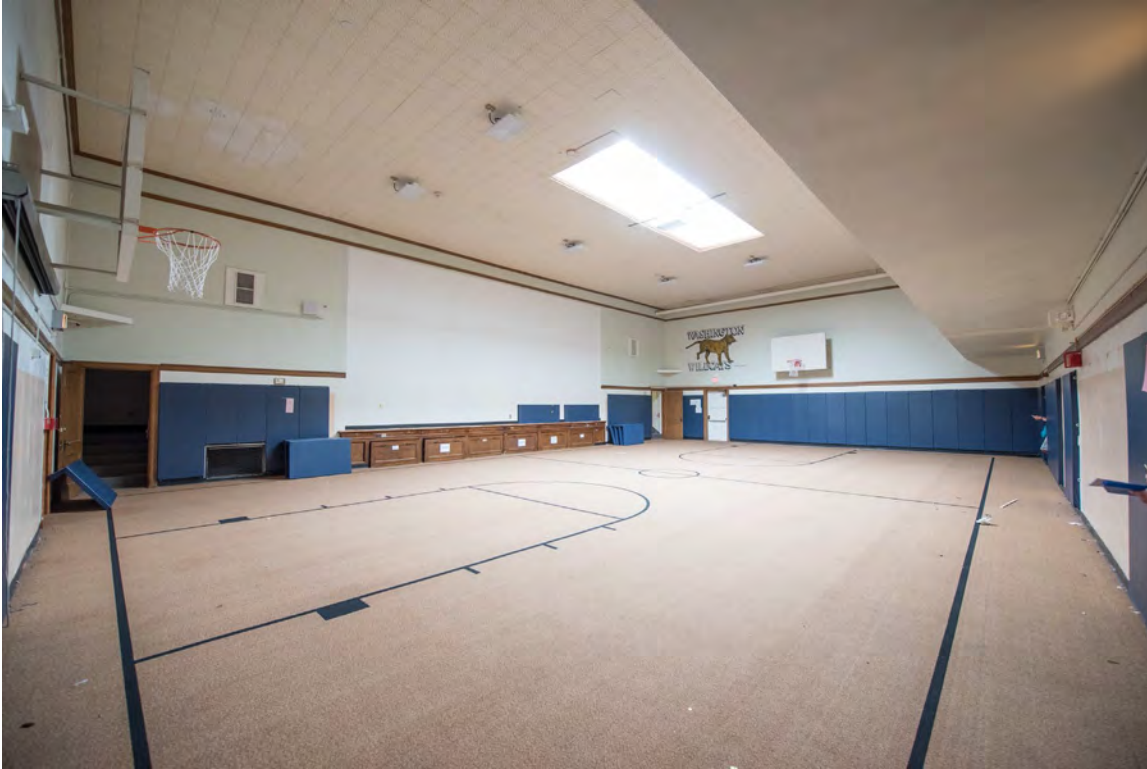
Photo 15: 1931 Gymnasium with view of covered proscenium, facing northwest

The gymnasium has experienced some modifications. Gypsum board walls infill the proscenium on the western wall although the historic opening remains discernable due to a slight indentation between the infill and the historic plaster wall, and the historic wood storage drawers underneath the proscenium remain (**Photo 015**). The infilled balcony opening that formerly spanned the eastern wall also remains discernable due to a wood hand railing that spans the length of the balcony (**Photo 016**).

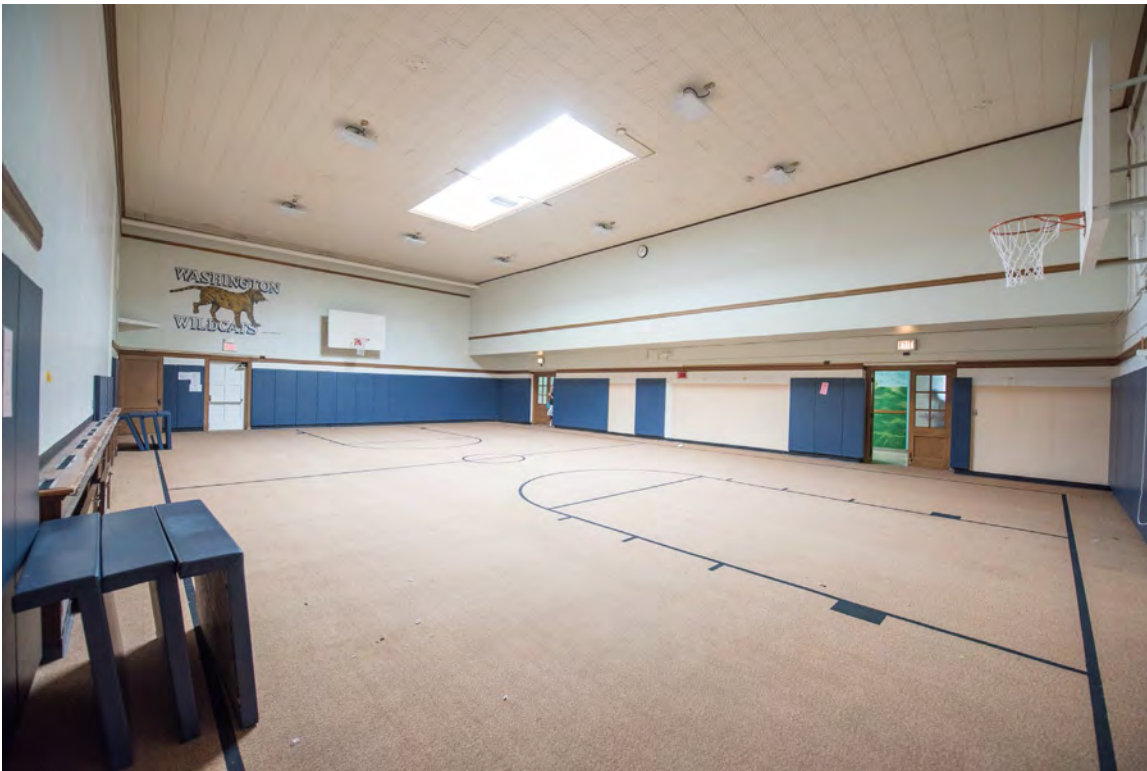
Photo 16: 1931 Gymnasium with view of covered balcony, facing northeast

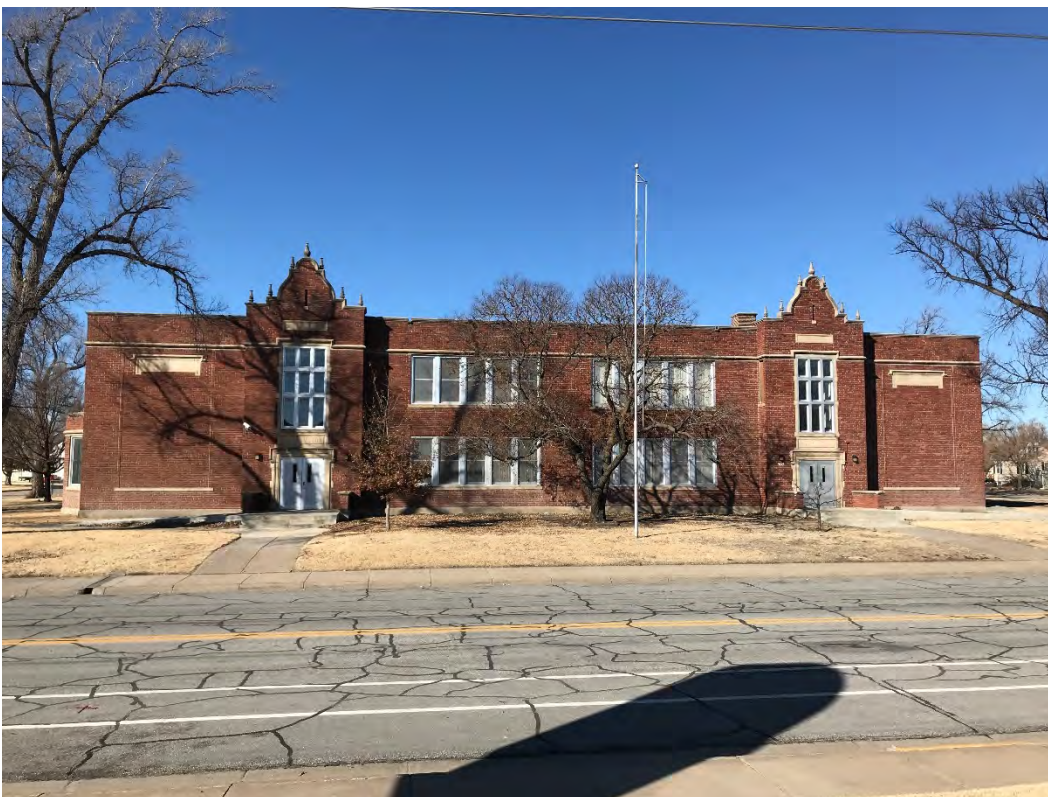
Photo 18: Full front (east) elevation, facing west, photo from JRG Architects, Spring 2020
